Samuel Myers Park Restoration Project

Engineering Plans Completed 8-2013

11 PHASE Implementation Plan

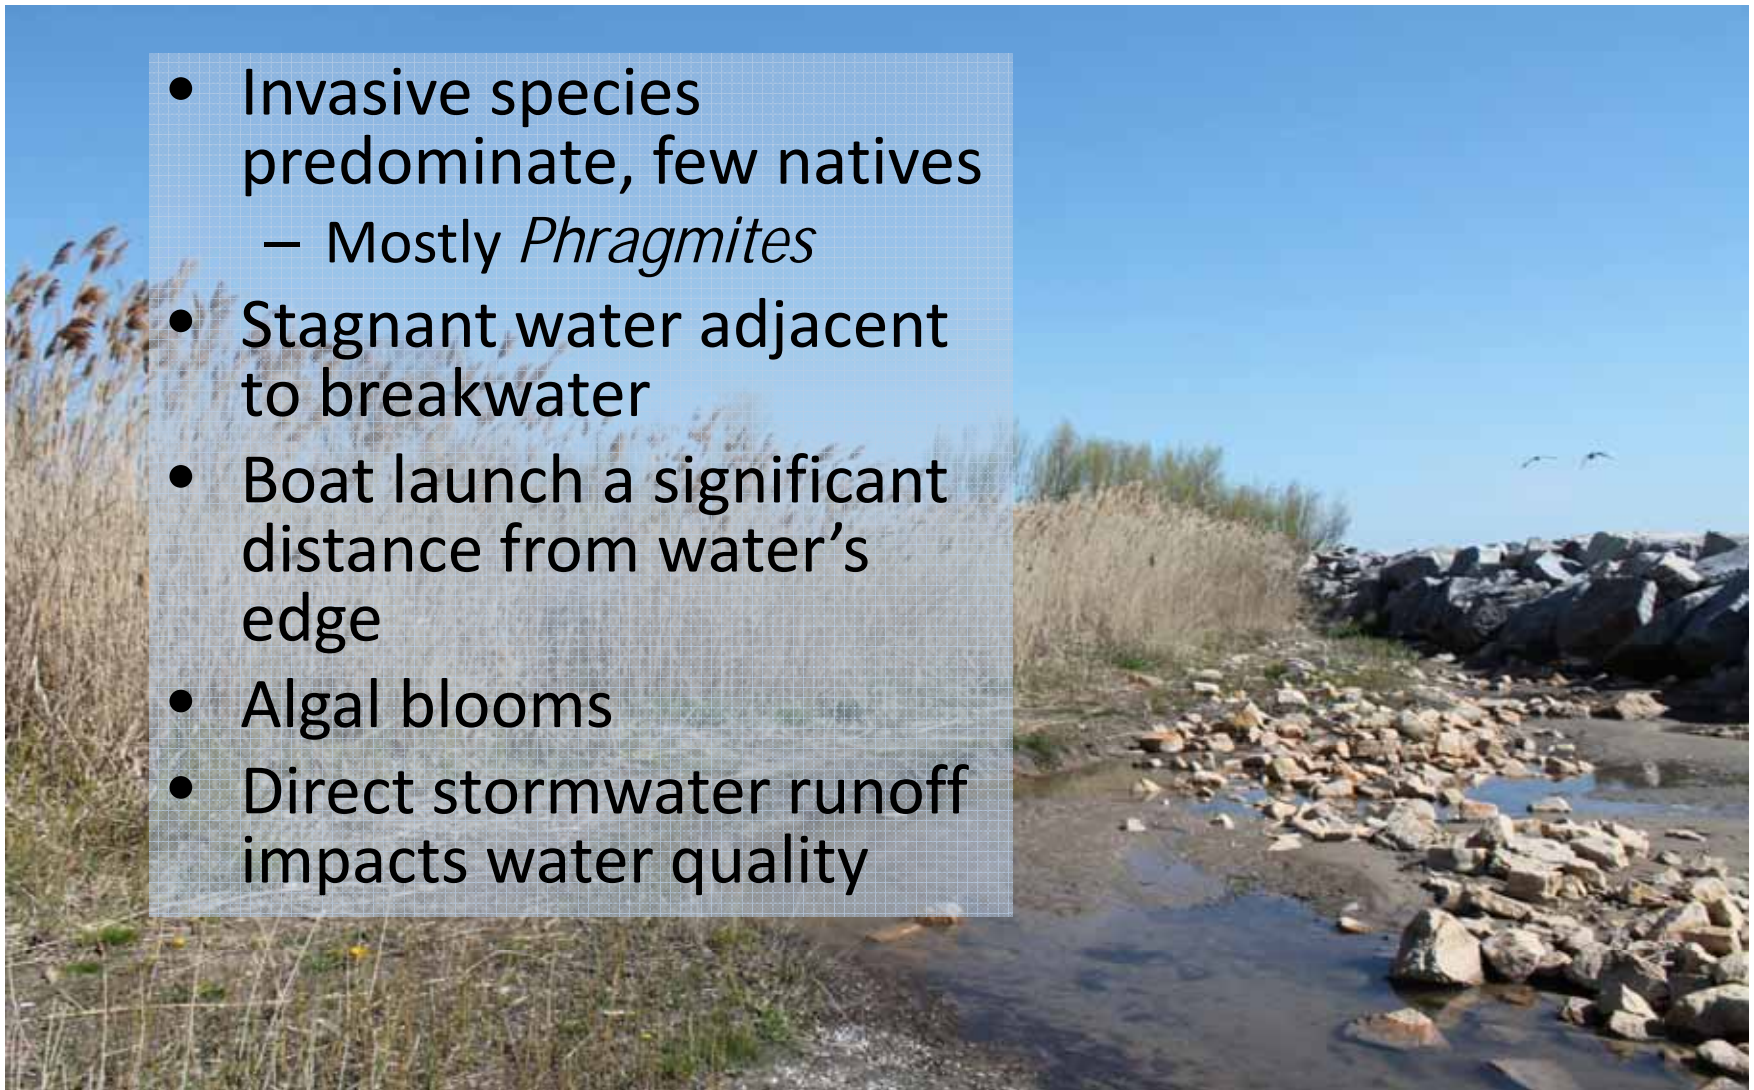
State of Sam Myers Park

- Invasive species predominate, few natives
 - Mostly *Phragmites*
- Stagnant water adjacent to breakwater
- Boat launch a significant distance from water's edge
- Algal blooms
- Direct stormwater runoff impacts water quality

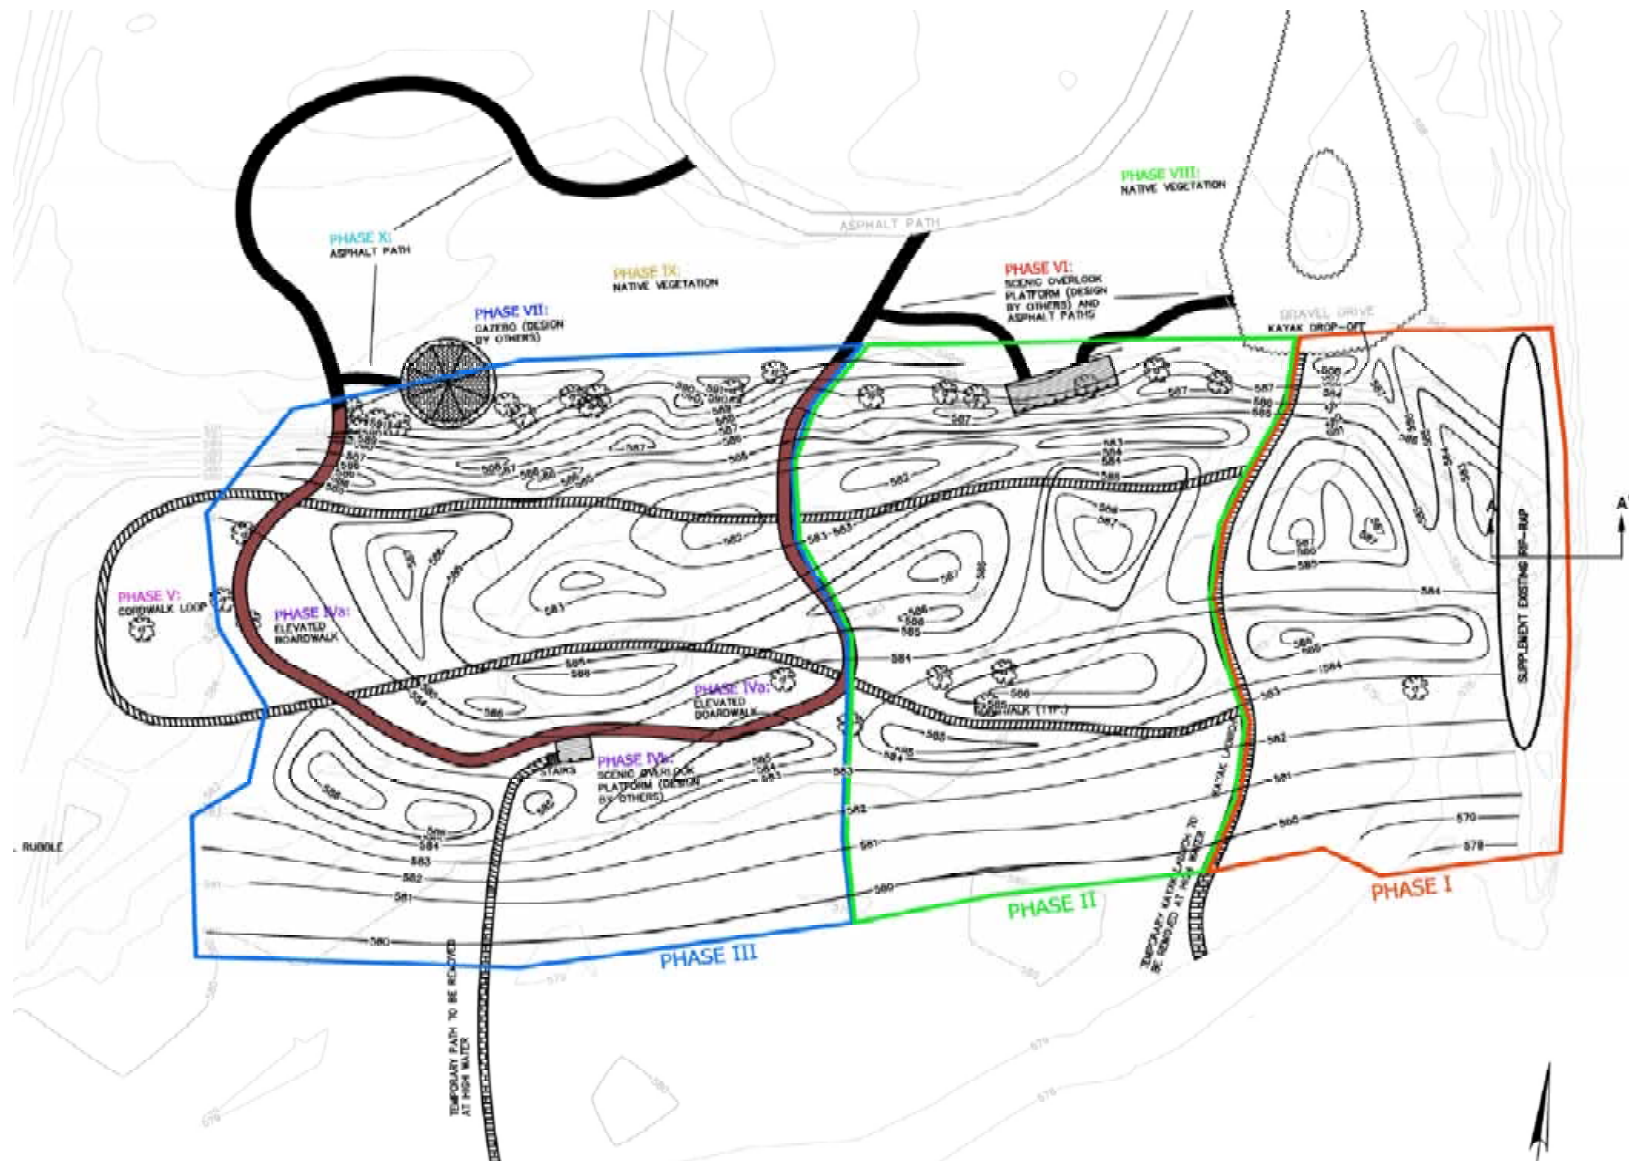
- Improve circle drive & parking lot
 - Rain gardens/bioswales to capture stormwater
- Raise 200 lin. ft. of breakwater by 3 ft.
- Lengthen canoe/kayak launch (permeable)
- Create walking paths (incl. ADA compliant access)
- Add passive use features (overlooks, benches,...)
- Use dune features to capture surface runoff
- Install native vegetation (habitat and aesthetics)
- Restore wetland area
