## ADDENDUM SUMMARY

# Wind Point Watershed Restoration Plan

## ADDENDUM ONE

July 21, 2017

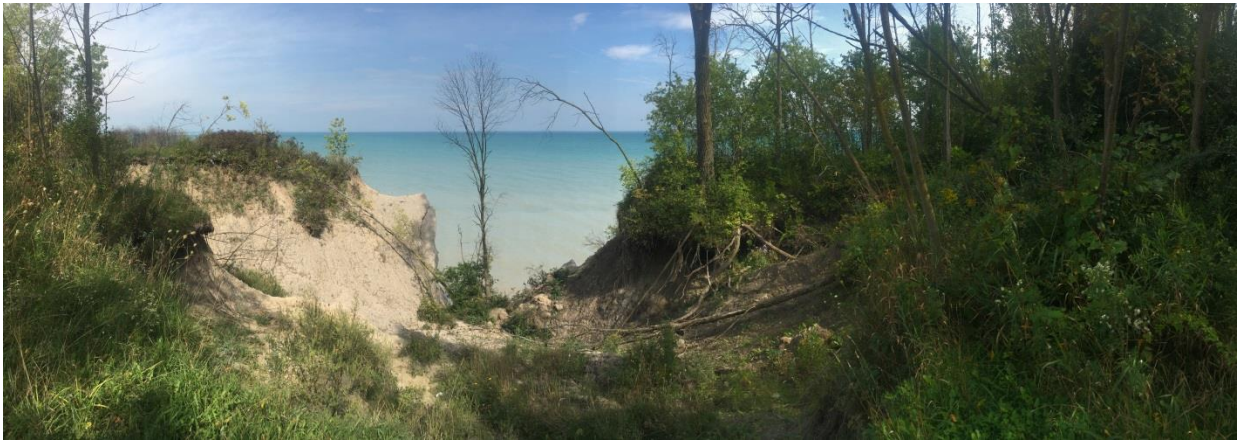
- i) Root-Pike WIN cannot speak for all of the ravines in the watershed, but we can speak to four of the major ones leading into and within Cliffside Park. These are listed as steams TRF-1, 2, 3 and 4. We have had four site visits to Cliffside Park with various engineers and experts, and it clear there are three, possibly four distinct issues with this particular part of the watershed (SMU-11).

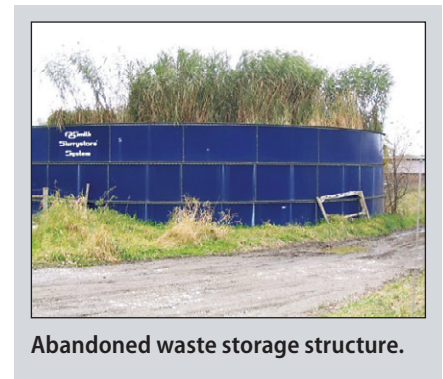
Abandoned waste storage structure.

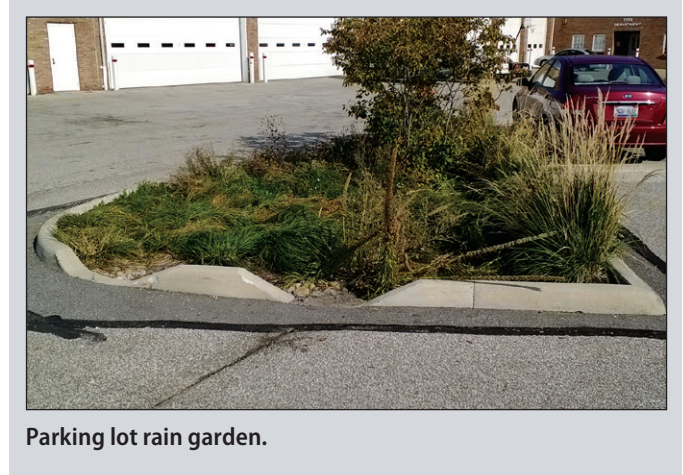
Parking lot rain garden.

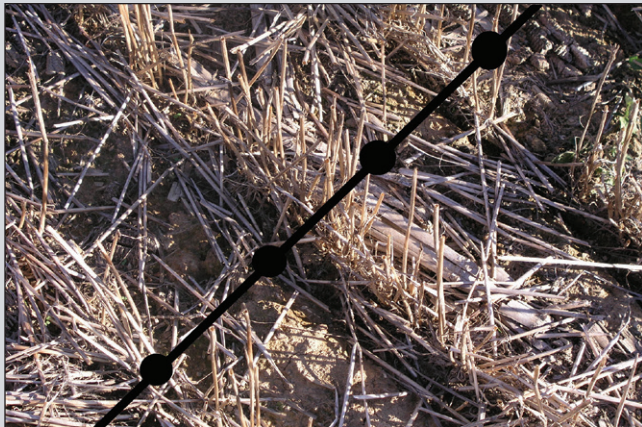
Illustration of line-transect method for residue.

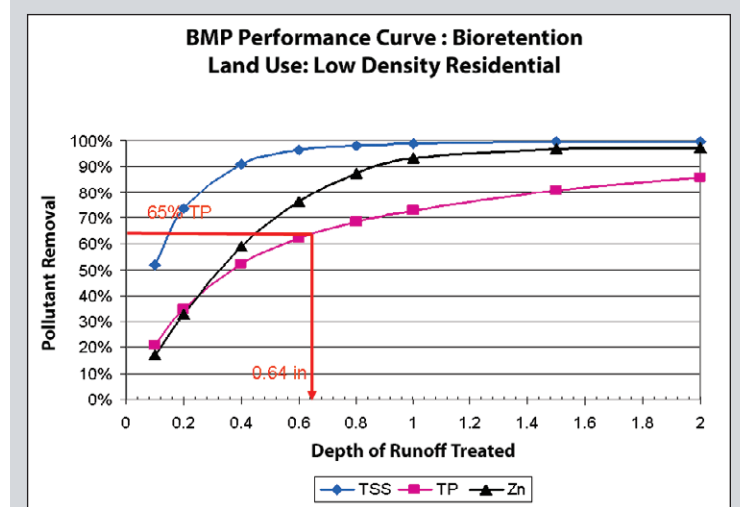
Figure 1. BMP Performance Curve for Bioretention BMP (Tetra Tech 2010).
