### 3.14 Watershed Drainage System

#### 3.14.1 Tributary Streams and Ravines to Lake Michigan

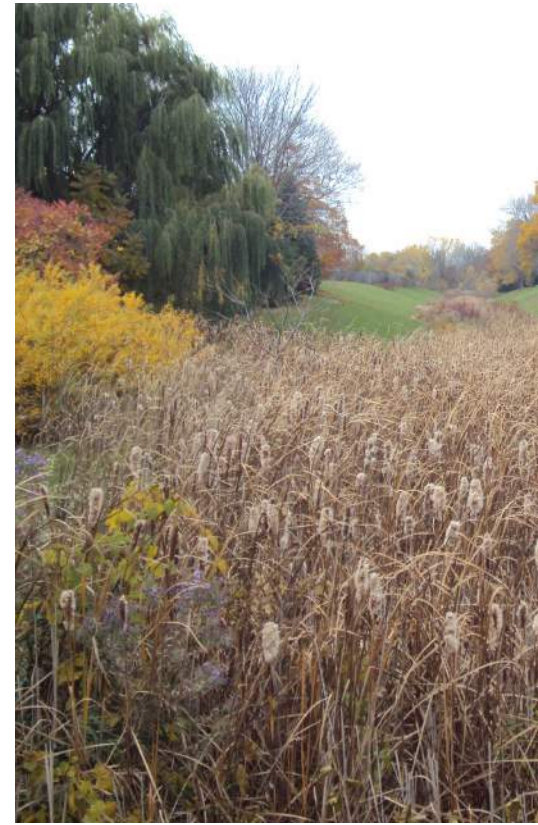
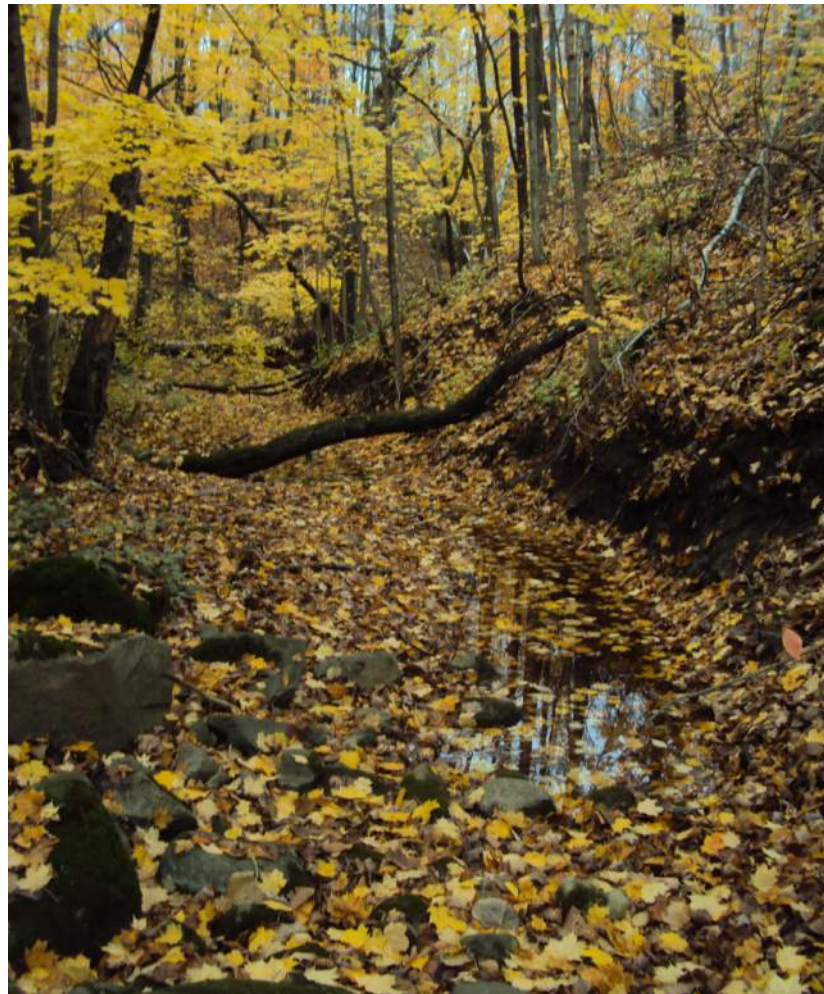
*Images, clockwise from left: Tributary A Reach 1 at 5th Avenue; Tributary D Reach 2 & Clay Ravine; Aerial view of Clay Ravine at Trib D Reach 2 (Source: Google Maps, 2013); Tributary B Reach 2 near Lake Michigan.*

Tributary A (Reach Code: TRA) is located in the northern tip of the watershed and drains approximately 279 acres of land in South Milwaukee. Tributary A is comprised of only one reach (TRA1) beginning near the Union Pacific Railroad and continuing east for 3,468 linear feet before reaching Lake Michigan. This stream is more or less a channelized swale dominated by wetland vegetation with a riparian area consisting mostly of old field and residential lots. Despite the somewhat degraded conditions, streambank erosion is low.

We Energies. Two reaches make up the tributary. Reach 1 (TRD1) flows primarily through a wetland complex but is disturbed. It is channelized, moderately eroded, and the riparian corridor is in poor ecological condition. Reach 2 (TRD2) is naturally meandering through high quality woodland prior to entering Lake Michigan but because the gradient is high, moderate streambank erosion is occurring and erosion is severe along a ravine formation near the lake known as Clay Ravine.

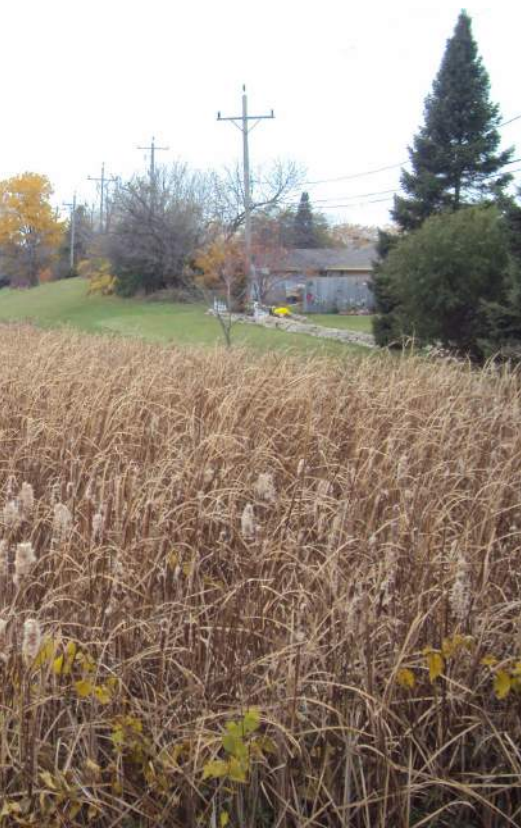
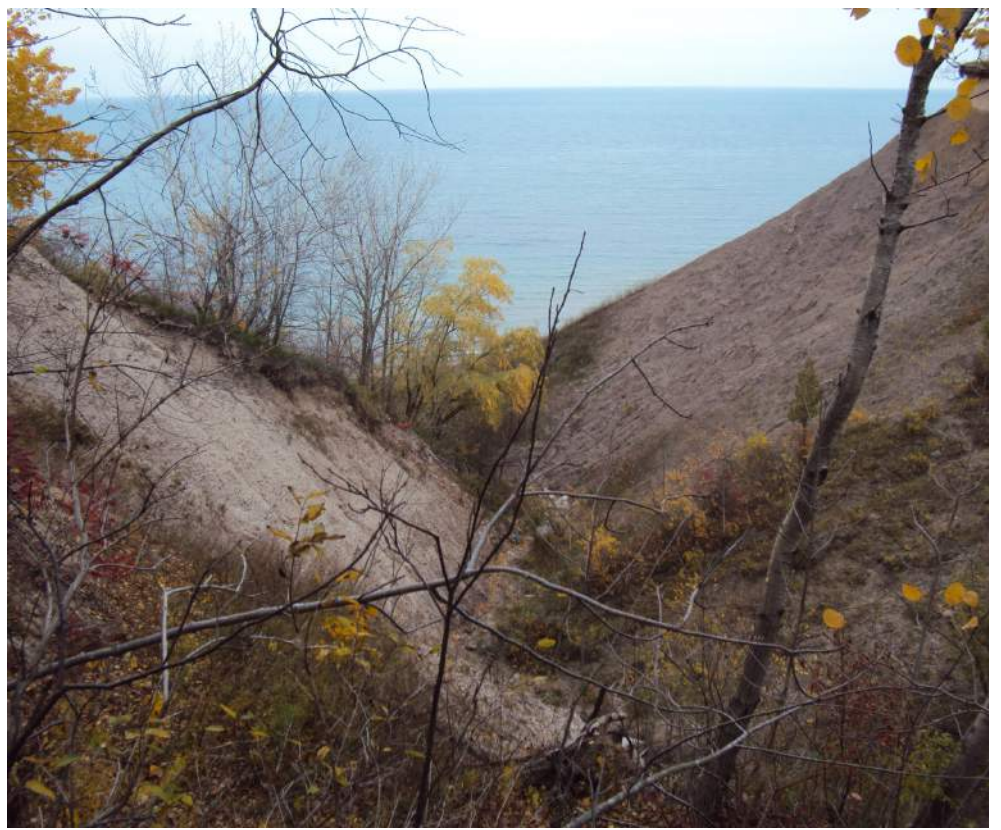
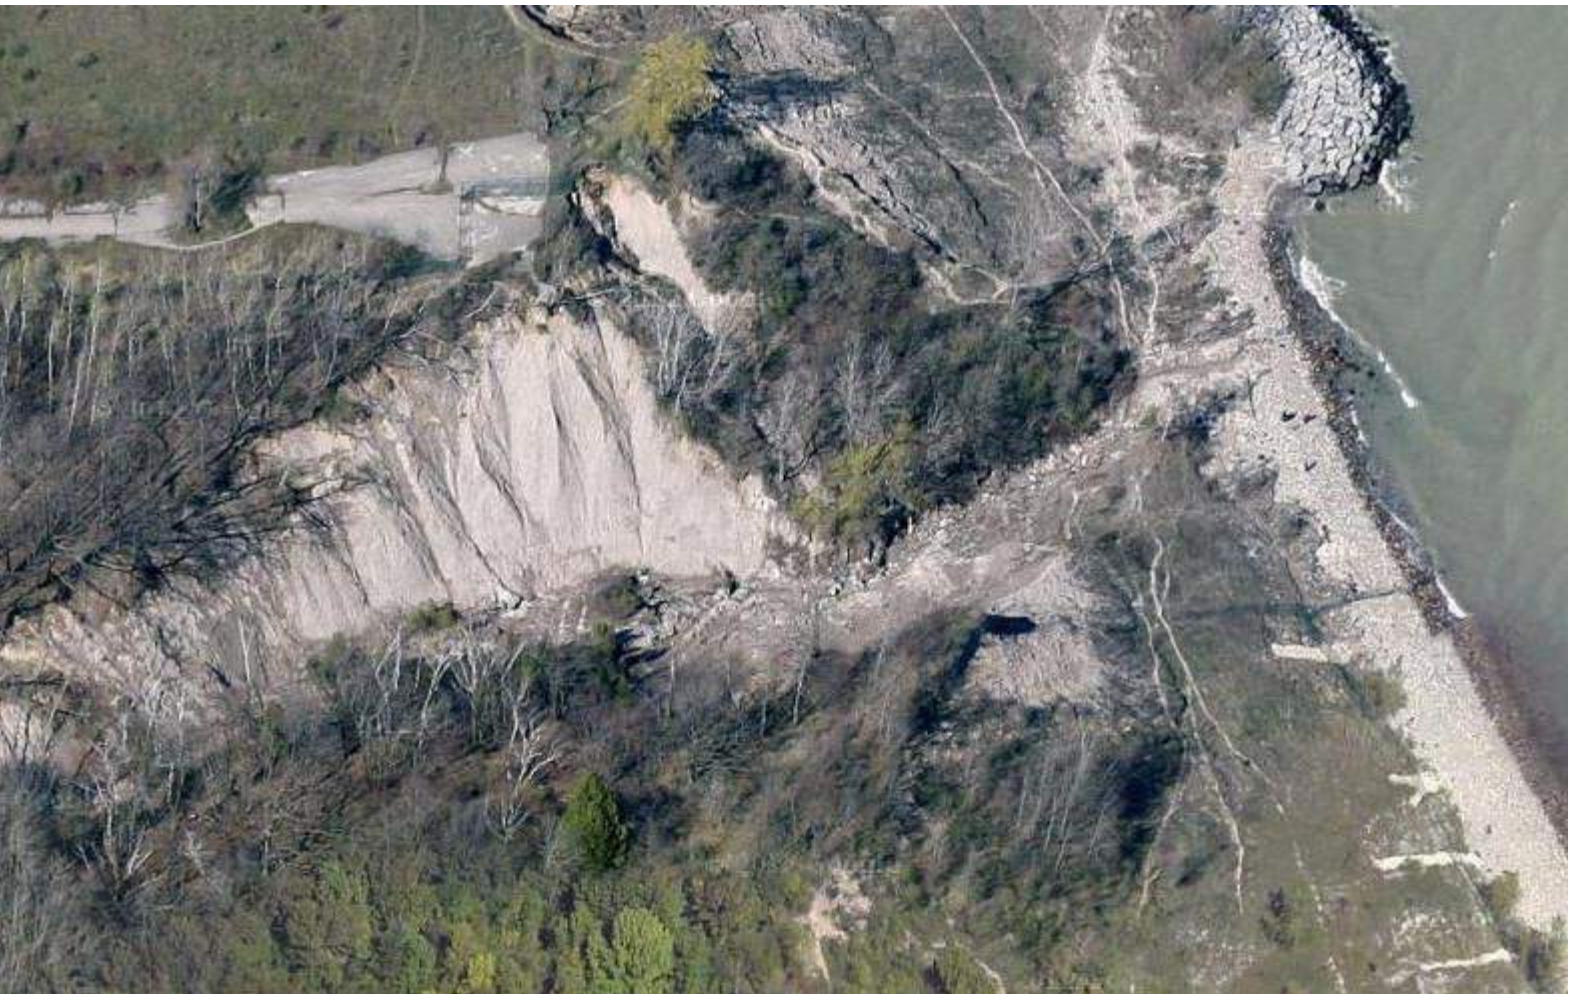
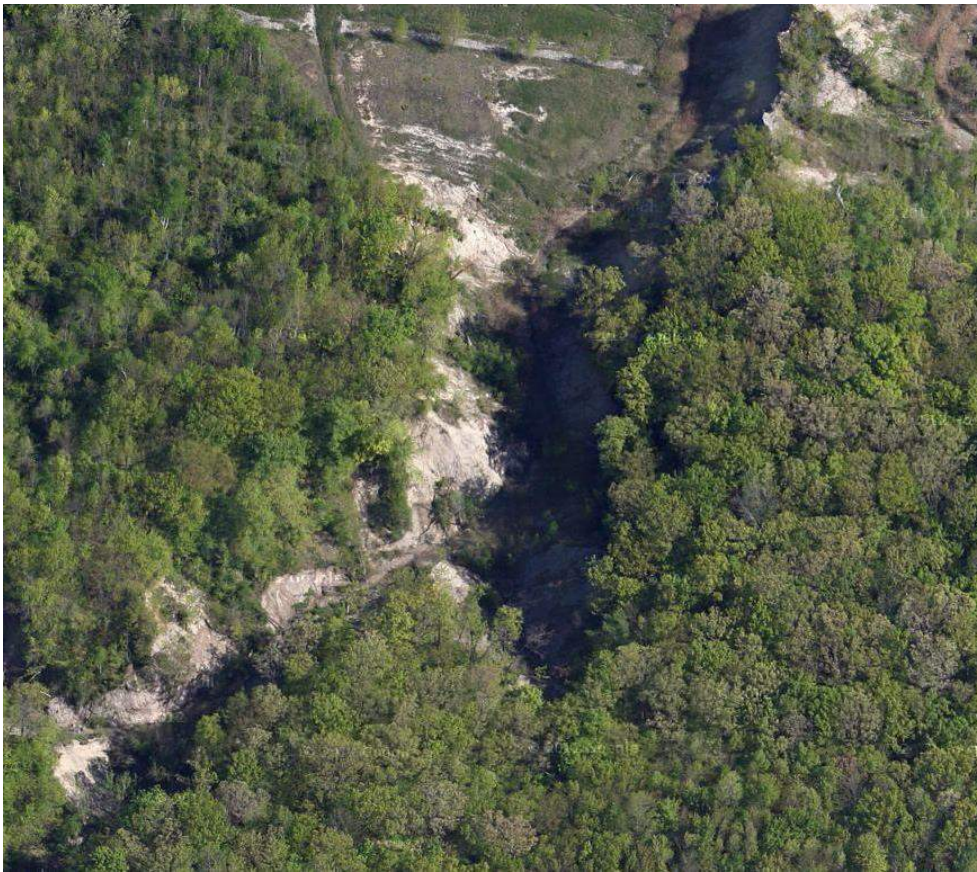
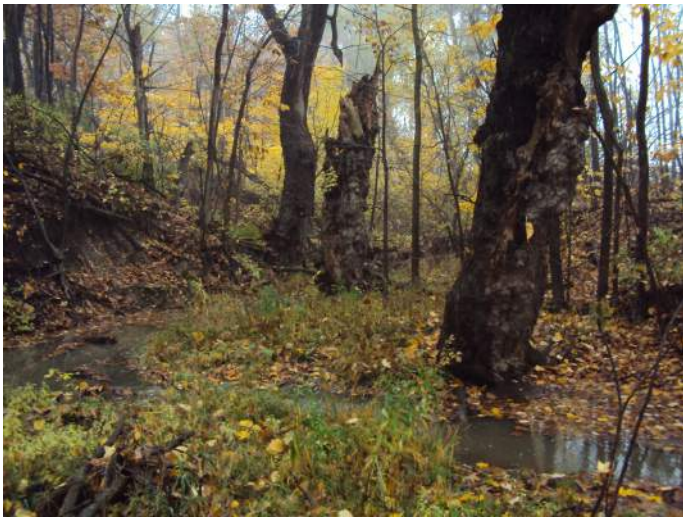
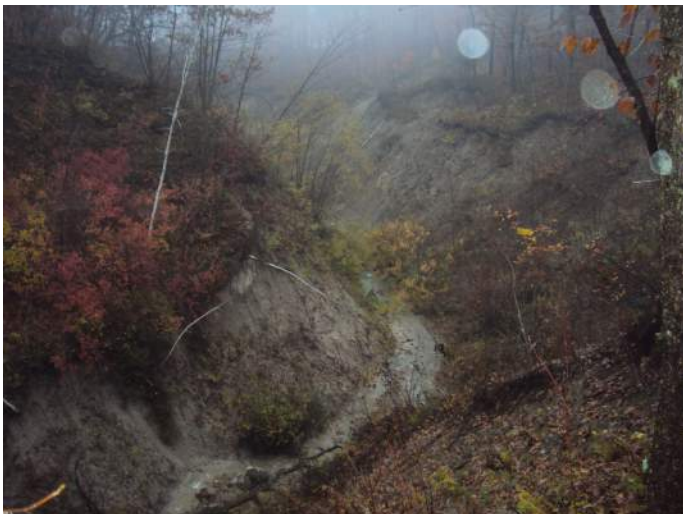
Images, counter-clockwise from top left: Aerial view of Rifle Range Ravine (Source: Google Maps, 2013); Tributary E Reach 2; Tributary E Reach 3 – Rifle Range Ravine; Tributary E Reach 5; Tributary F Reach 1; Trib F Reach 2 upstream of headcut; Trib F Reach 3 downstream of headcut

Tributary E & Rifle Range Ravine  
 Tributary E (Reach Code: TRE) is known locally as Rifle Range Tributary. The six stream reaches making up Tributary E span 14,550 linear feet draining 947 acres of land. Reach 1 (TRE1) begins in a wetland complex just west of State Highway 32 and flows northeast to just north of 7 Mile Road on We Energies property. Most of this reach suffers from past agricultural disturbance such as channelization and a narrow/degraded riparian corridor. Reach 2 (TRE2) is located entirely on We Energies property. This reach is naturally meandering with a riparian corridor in good ecological condition. The most concerning issue is the presence of a severe headcut at the end of Reach 2 that is migrating upstream causing significant erosion and sediment transport to Lake Michigan. Reach 3 (TRE3) begins at the headcut and continues downstream to Lake Michigan. This reach is a deep ravine (Rifle Range Ravine) exhibiting severe erosion through a high quality oak woodland. Reaches 4 and 5 (TRE4&5) are essentially wetland swales located between State Highway 32 and the C&NW Railroad. These two reaches come together to form the beginning of Reach 6 (TRE6) which meanders naturally through a high quality oak woodland before joining Reach 3. Similar to Reach 2, there is a headcut that is migrating upstream within Reach 6 and is causing erosion and

ecological condition. This reach is also highly channelized through the residential area via a human constructed concrete channel. Reach 2 (TRF2) begins on the south side of Cliffside Park and meanders northeast through a floodplain forest until it reaches a headcut that is actively migrating upstream. A similar condition was observed along Reach 3 (TRF3). This reach is stable and meandering through a wooded riparian area up to a second headcut. Reach 4 (TRF4) is located between the headcuts along Reaches 2 and 3 and Lake Michigan. Reach 4 forms a ravine

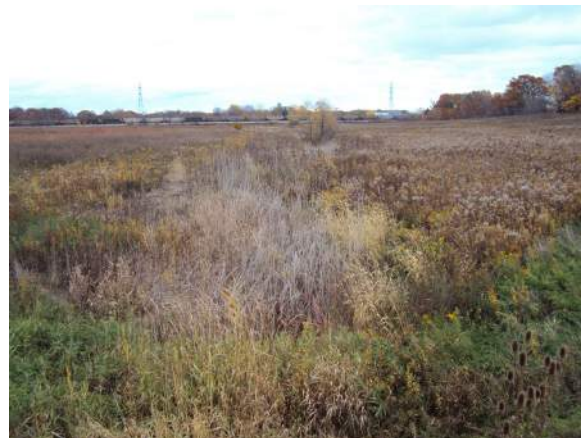
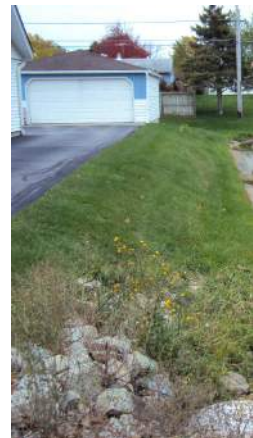
A headcut is an erosional feature of both intermittent and perennial streams where an abrupt vertical drop, also known as a knickpoint in the stream bed occurs following hydrologic disturbances in the contributing watershed. As erosion of the knickpoint and the streambed continues, the headcut migrates upstream. This can cause significant streambank erosion and often results in a disconnected floodplain that then increased channel incision.

Controlling a headcut is one of the most difficult challenges in stream restoration. Common headcut treatments include installing check dams, or sloping the bank face and laying in fabric and rock to control continued upstream migration of the knick point. Other methods for headcut control are to elevate the incised channel by filling to original grade.

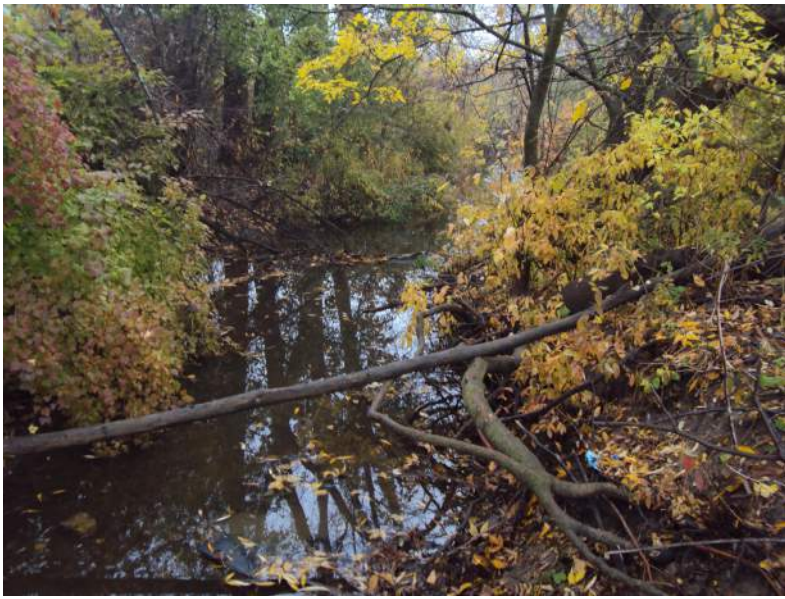
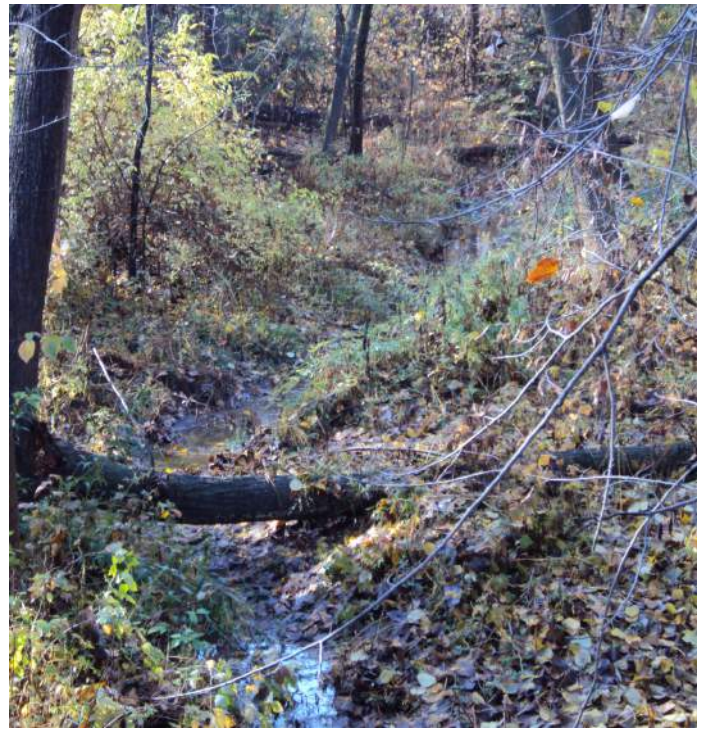
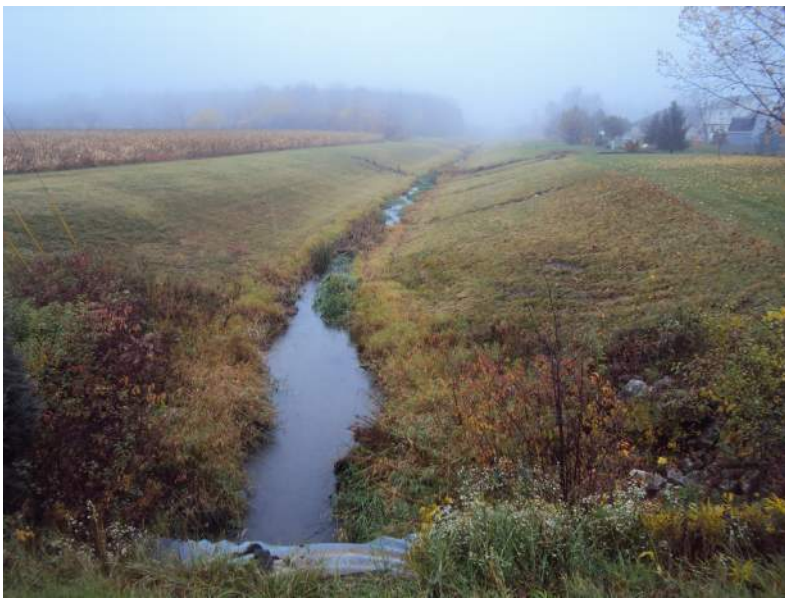
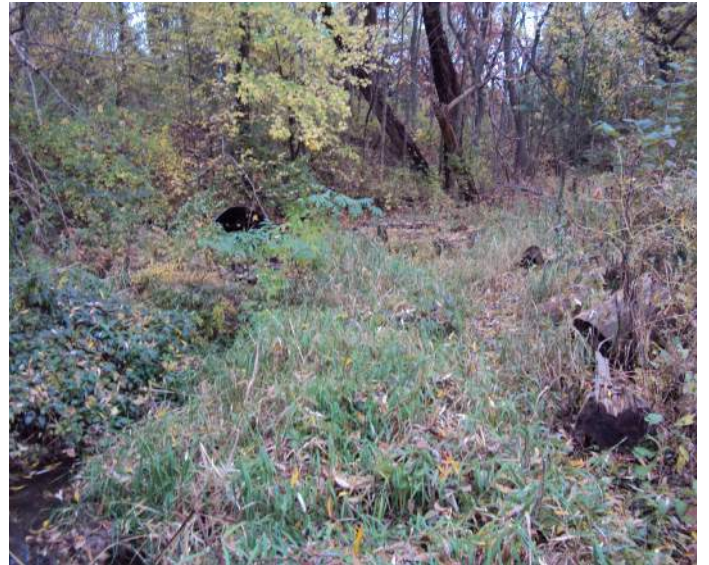
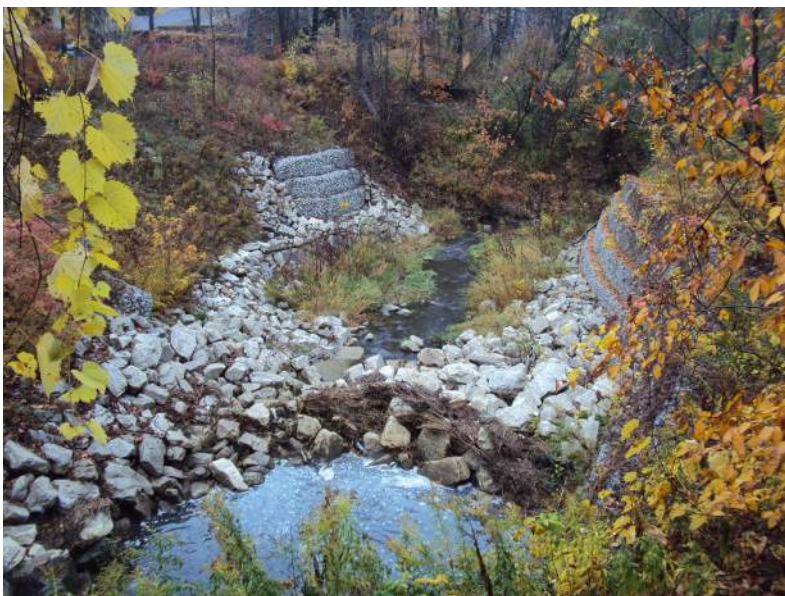
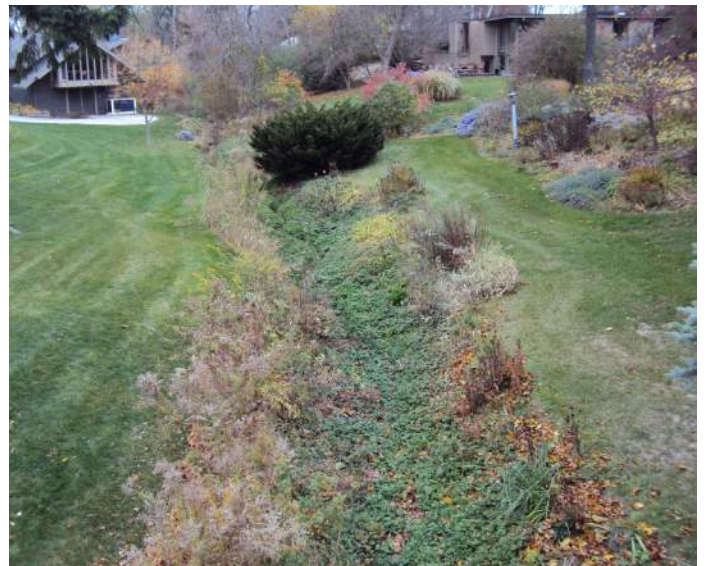
*Images, top to bottom, left to right: Tributary G Reach 3; Tributary G Reach 5; Tributary G Reach 7; Tributary I Reach 1; Tributary J Reach 1; Tributary L Reach 1.*

Tributary G (Reach Code: TRG) is known locally as Turtle Creek. The seven stream reaches that combine to form Tributary G result in the longest tributary in the watershed at 34,679 linear feet or 6.6 miles. It drains about 2,138 acres or 3.3 square miles within the central portion of Caledonia. Tributary G has likely been altered the most by human activities. Many of these alterations including channelization and channel relocation can be observed by looking at the pre-settlement stream mapping depicted on Figure 6 in Section 3.1 and comparing it to existing mapping on Figure 36. Reaches 1 and 6 are the small tributaries that join two larger tributaries. Reach 1 begins just east of State Highway 31 and runs through turf grass lined channels within a residential subdivision prior to joining Reach 2 just east of State Highway 32. Reach 6 is mostly channelized within an agricultural parcel between Catherine Drive to the north and Rebecca Drive to the south. Reaches 2 and 3 are somewhat similar. Reach 2 begins west of State Highway 31 and flows east to the Union Pacific Railroad through a moderately channelized system. Reach 3 begins at the railroad and joins Reach 5 near 5 ½ Mile Road. Both reaches are buffered by relatively narrow/low quality floodplain woodlands.

Tributary I (Reach Code: TRI), also known as Dominican Creek Ravine, flows for 5,880 linear feet and drains 443 acres of land between Charles Street and Lake Michigan in Caledonia. The one reach (Reach TRI1) comprising the tributary flows through a wide floodplain forest that is in good ecological condition. Overall, the stream channel is also in good condition. Streambank erosion is low and the channel is naturally meandering. The Hey and Associates ravine study identified down-cutting of the streambed and the toe of the banks as well as slumping of the ravine banks at the toe of slope as general erosion and

Tributary J (Reach Code: TRJ), also known as Birch Creek Ravine, is 7,468 linear feet in length and drains 1,040 acres of mostly residential land in the Villages of Caledonia and Wind Point. The tributary begins near the intersection of Erie Street and 4 Mile Road. From there, Tributary J flows east to near Ravenswood Lane before turning sharply to the north and to Lake Michigan. Tributary J is generally in good condition. It is naturally meandering along its length with no significant streambank erosion problems. And, the riparian corridor consists of floodplain forest in average ecological condition. The Hey and Associates ravine study concurred that generally the area was stable as were structures within this ravine, but noted excessive sediment loading in one section of the stream.

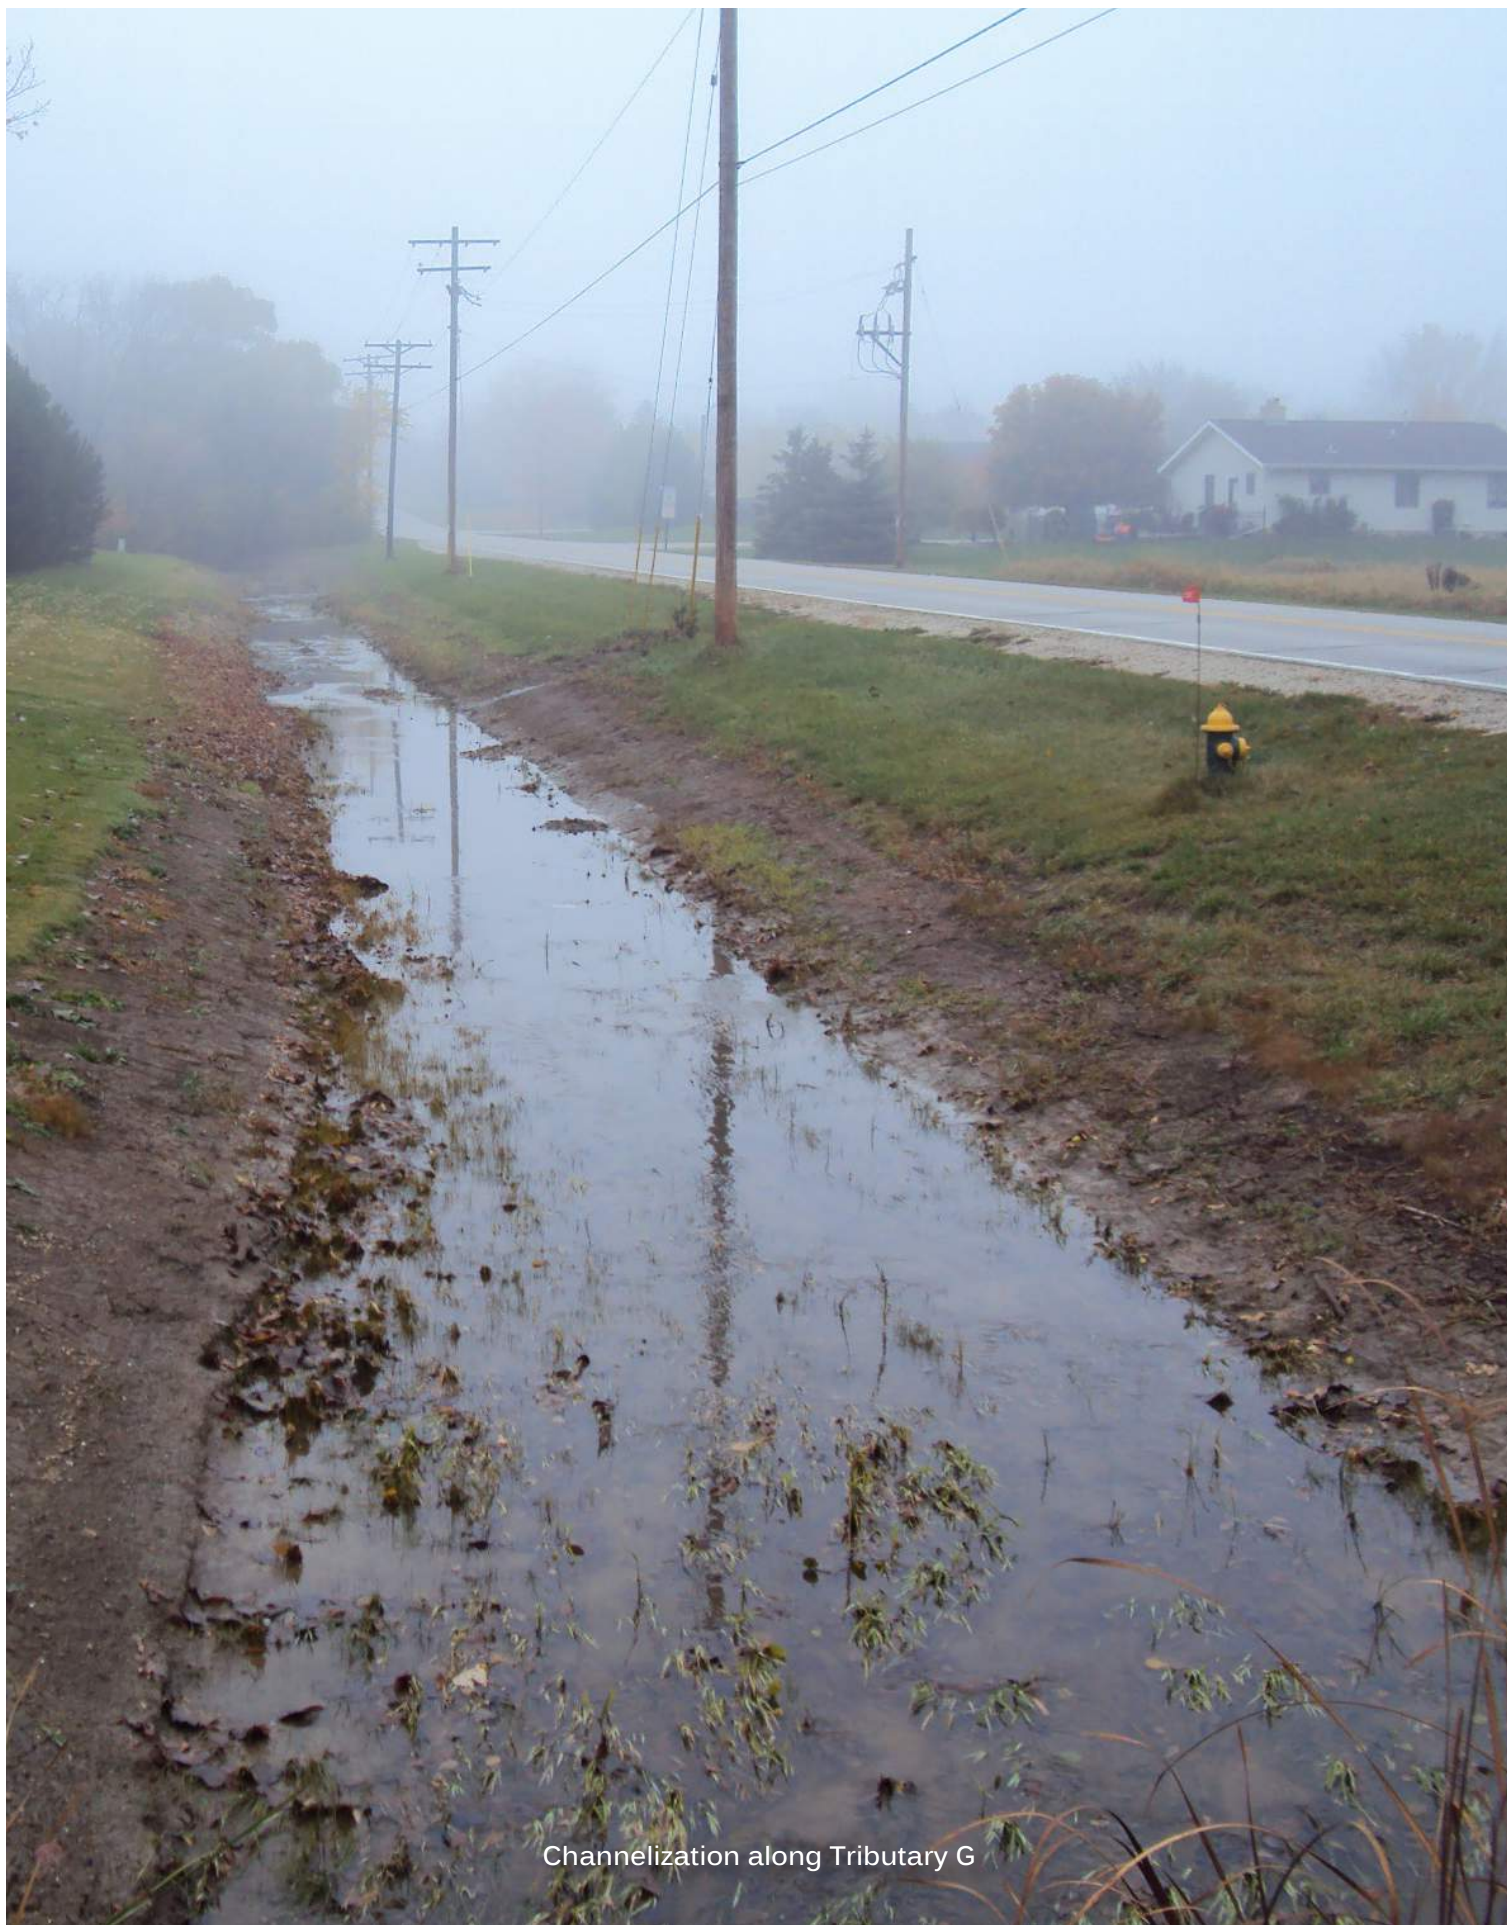
Channelization along Tributary G

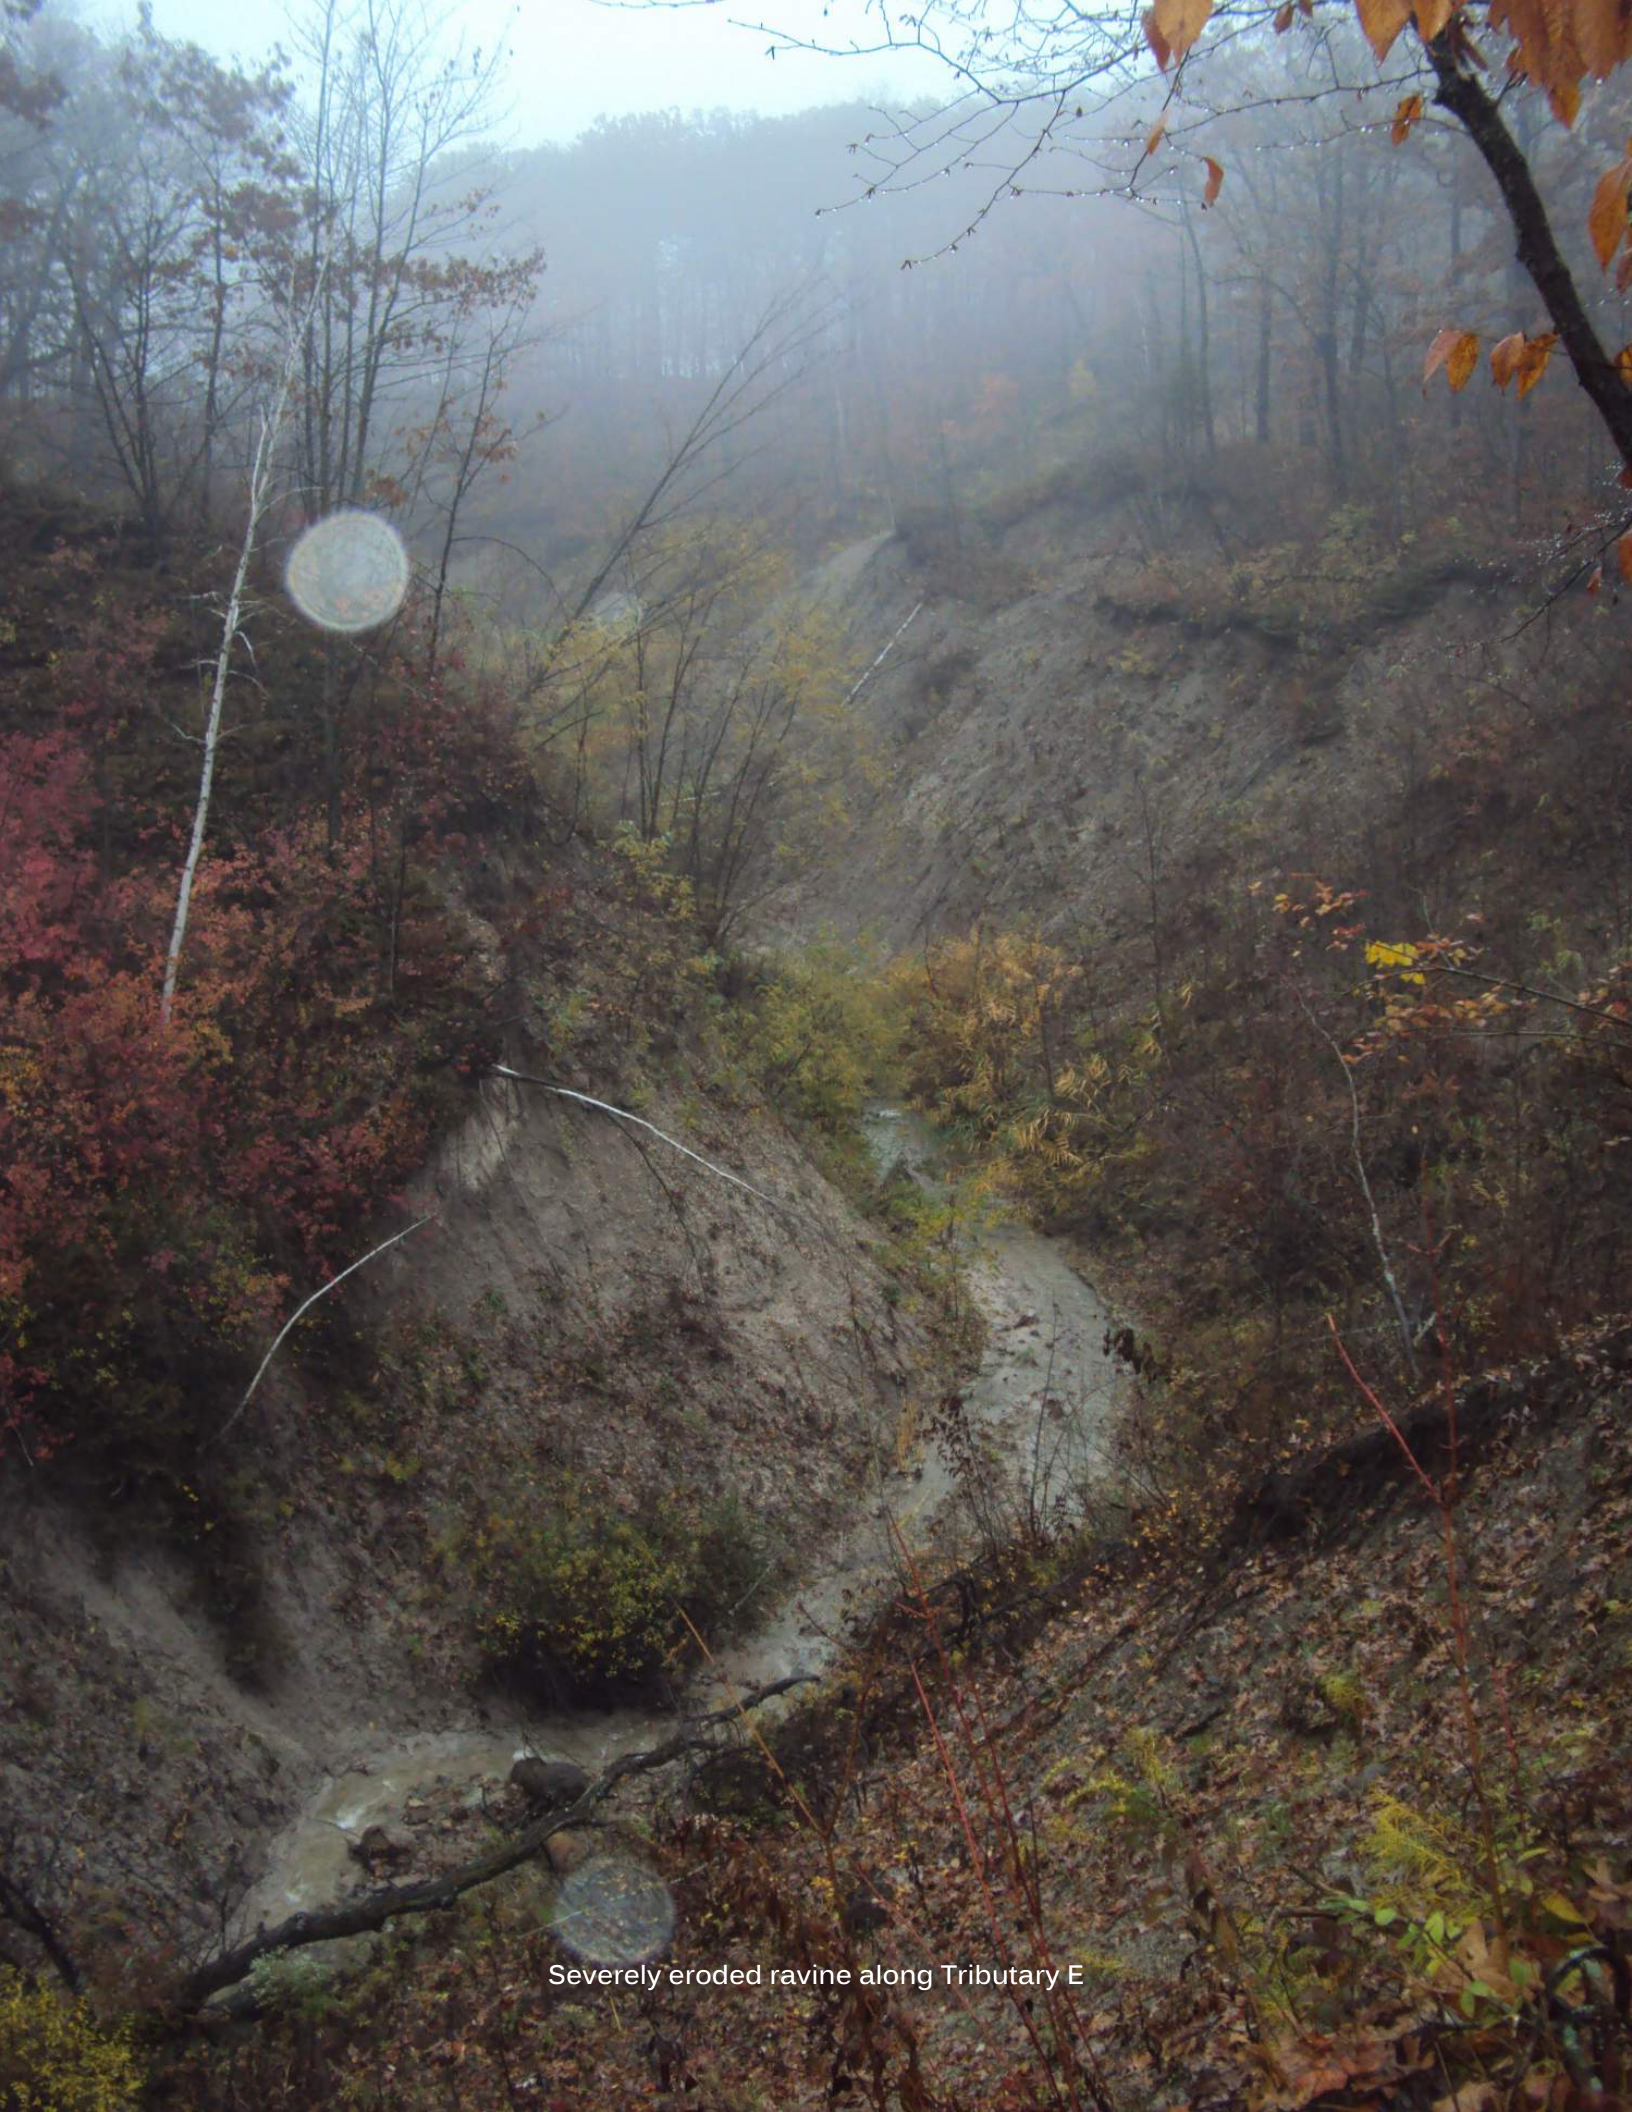
Severely eroded ravine along Tributary E

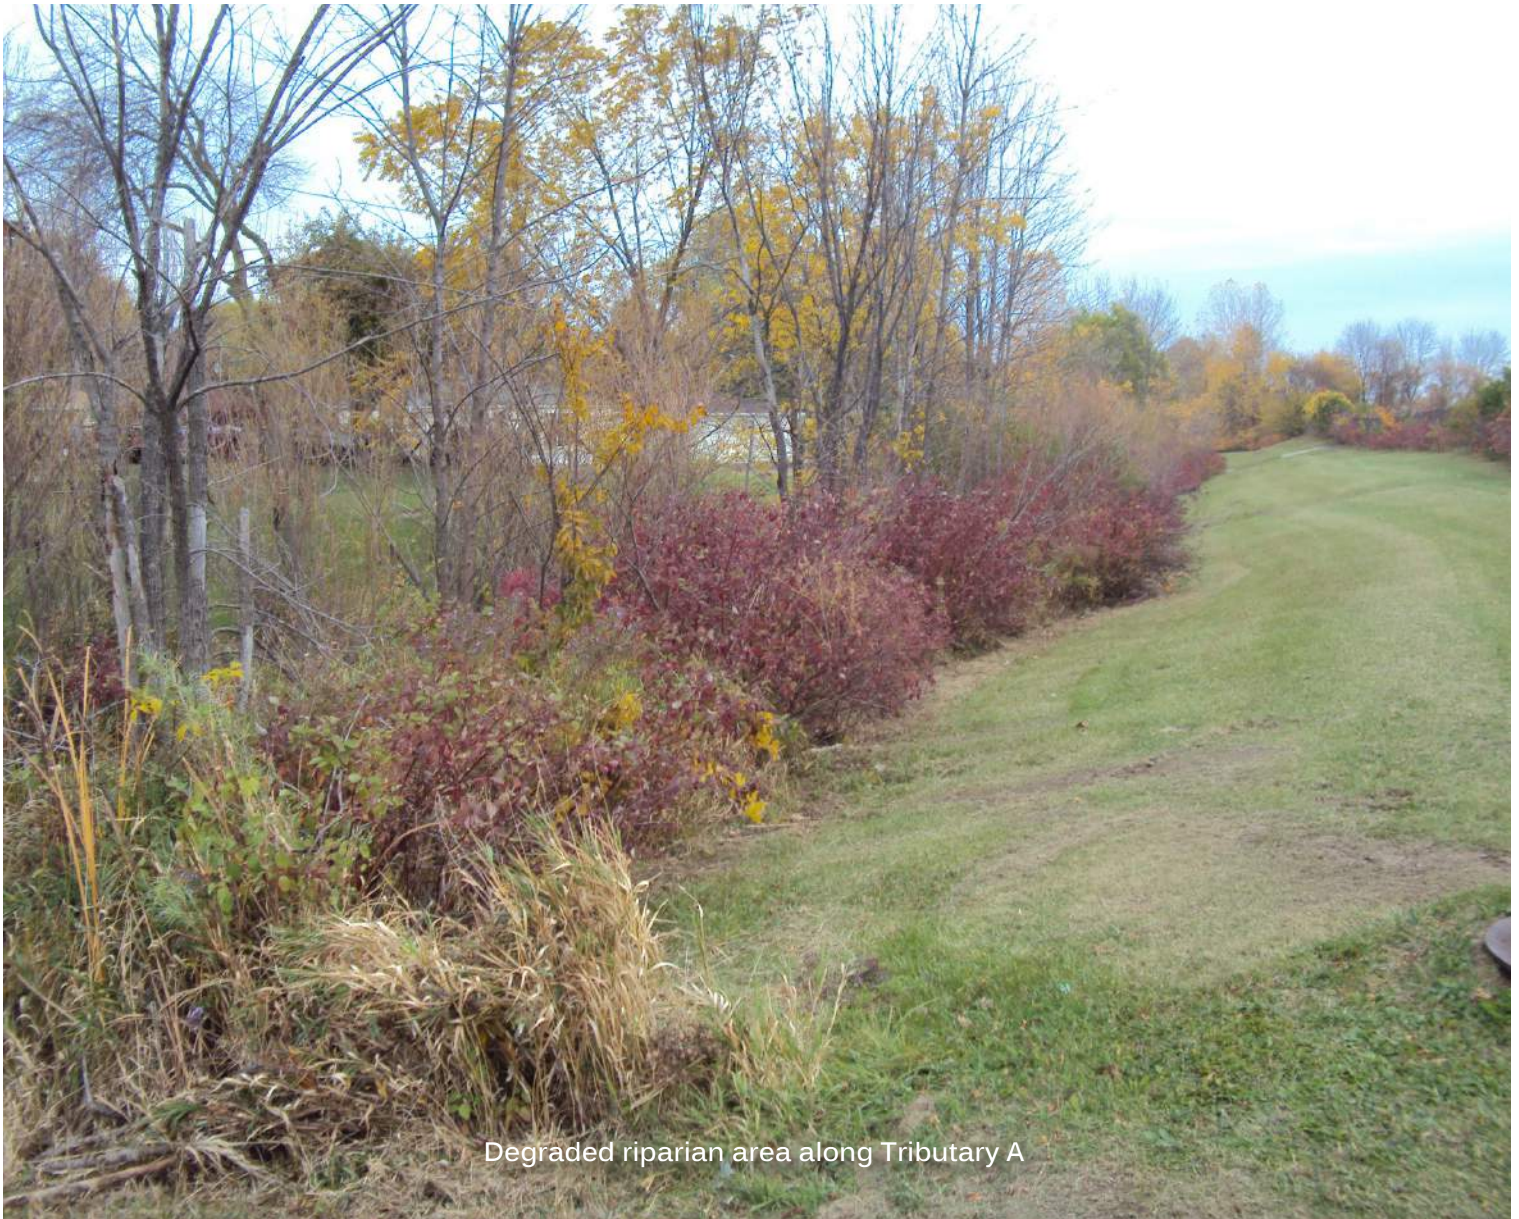
Degraded riparian area along Tributary A

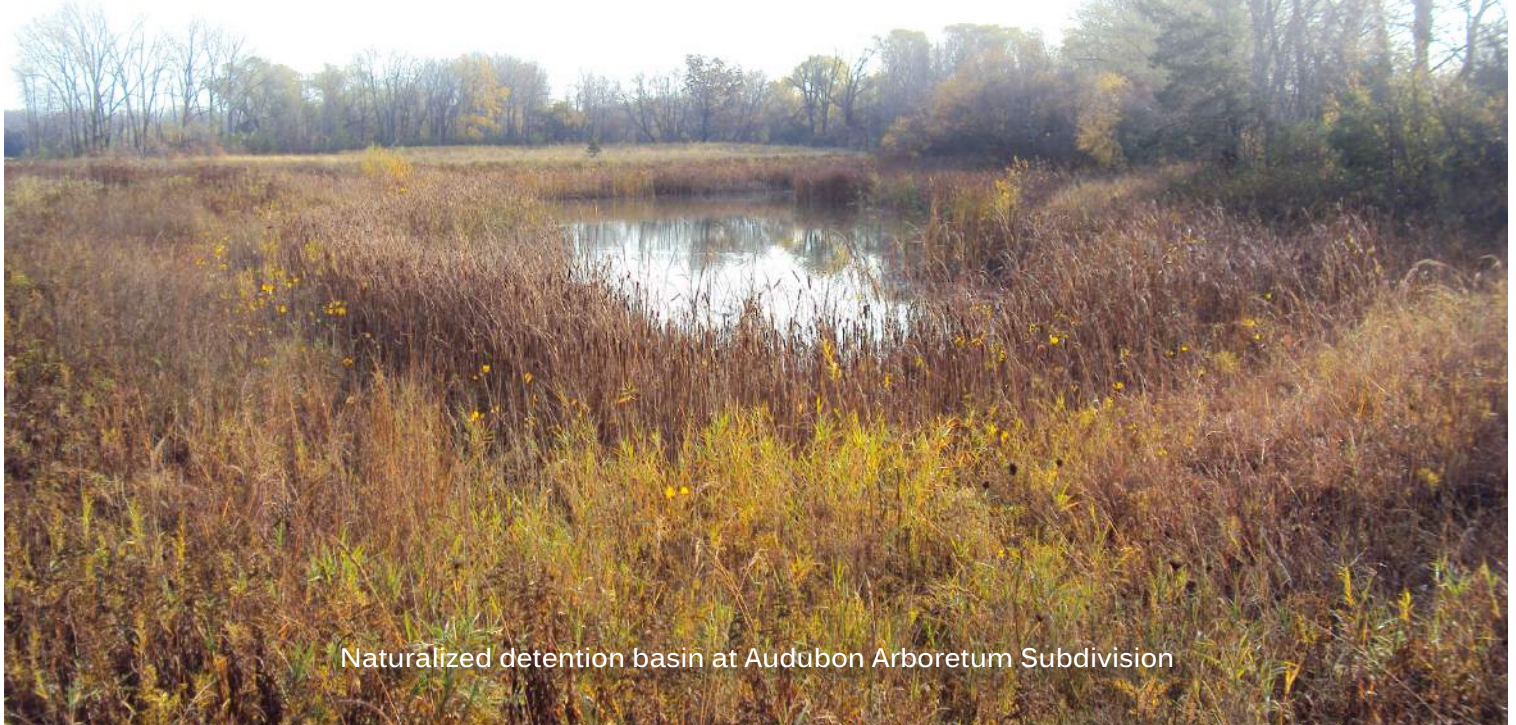
Naturalized detention basin at Audubon Arboretum Subdivision

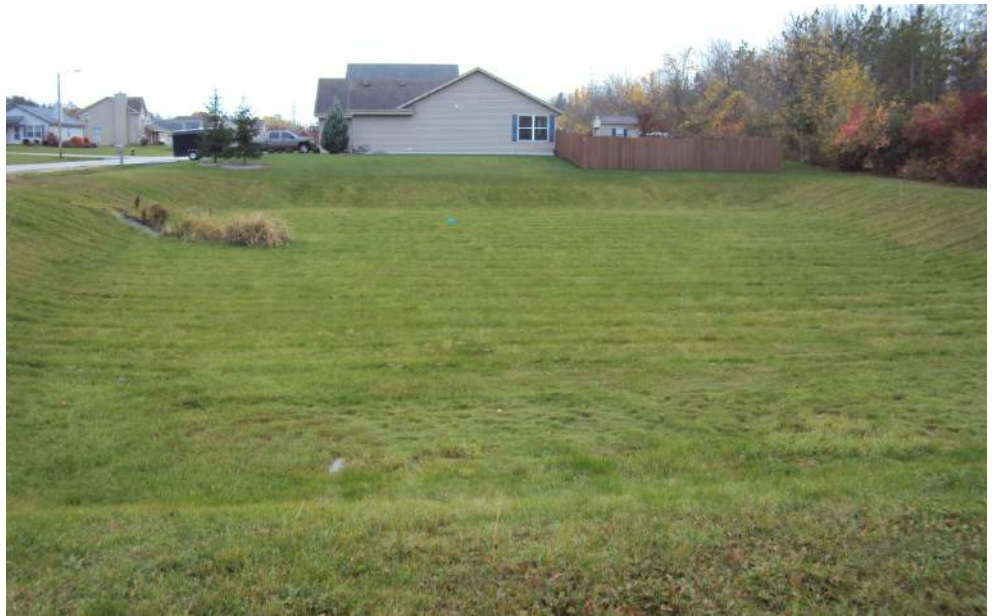
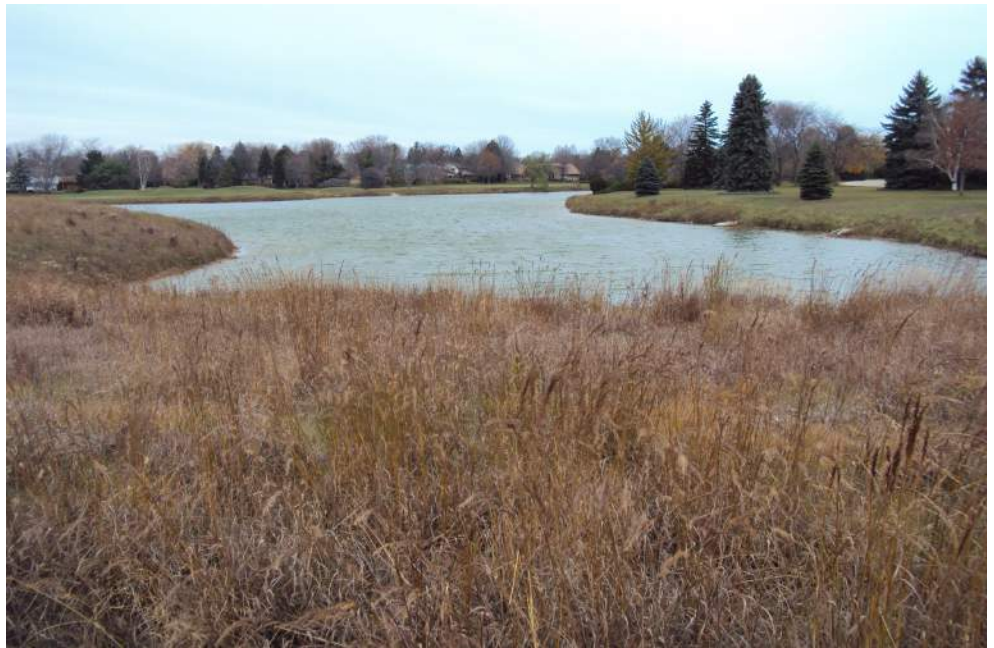
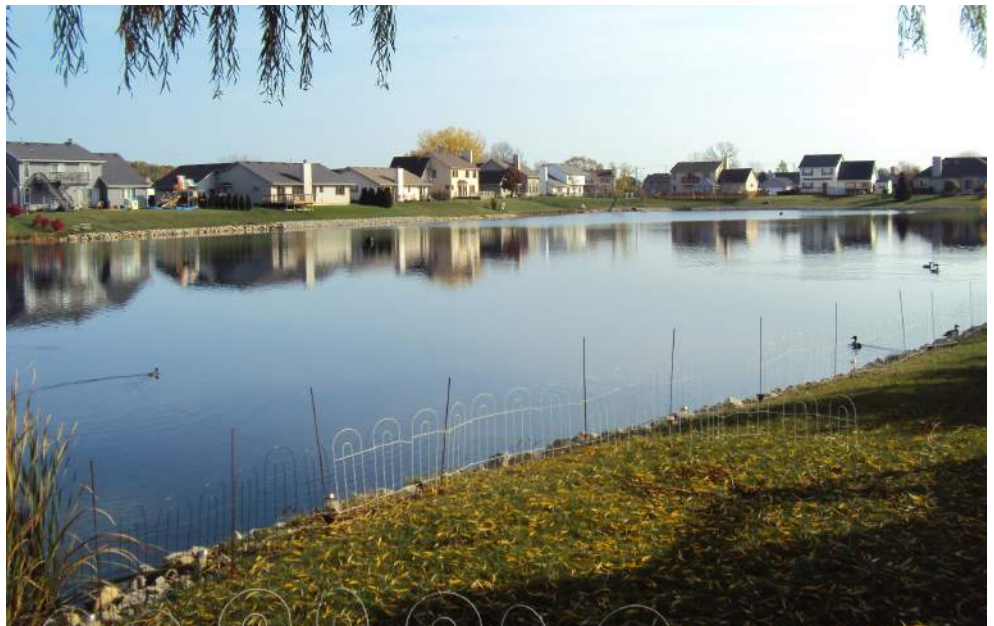
*Images, top to bottom: Typical dry bottom turf grass detention at Stephan Rd.; naturalized section of pond at Prairie School; wet bottom basin with turf slopes in development off Shore Dr.*

The majority of dry bottom detention basins are located in the southern half of the watershed within the municipalities of Caledonia and Racine. Of the 10 dry bottom basins in the watershed all are planted with turf grass. Unfortunately, turf grass basins provide limited water quality benefits and wildlife habitat. Dry bottom basins planted with turf grass hold water for shorter periods following rain events and infiltrate less water compared to dry bottom basins naturalized with deep rooted native vegetation. Many of the dry bottom basins in the watershed present excellent retrofit opportunities and most would be relatively easy to naturalize with native plantings.

Wet and wetland bottom detention basins are found scattered throughout the watershed. Individual development sites tend to have basins that are all similarly planted. For example, most wet and wetland bottom basins in a development are planted with either turf grass along the basin slopes or are naturalized with native vegetation along the slopes and emergent edge. Basins planted with turf grass are designed with aesthetics in mind and not necessarily the potential water quality and wildlife habitat benefits. Because of this, most homeowner and business associations will likely disapprove of installing water quality retrofits such as native plant buffers unless they can be designed to look formal and require minimal maintenance. Thirteen (13) of the 29 wet and wetland bottom detention basins in the watershed are naturalized with native vegetation. Perhaps the best example of naturalized basins can be found at Audubon Arboretum Subdivision in Caledonia. The remaining 16 wet and wetland bottom basins have turf grass slopes. Like most dry bottom basins, the side slopes and emergent areas of wet and wetland bottom basins can be retrofitted with native vegetation relatively easily.
