### 3.14 Watershed Drainage System

#### 3.14.1 Tributary Streams and Ravines to Lake Michigan

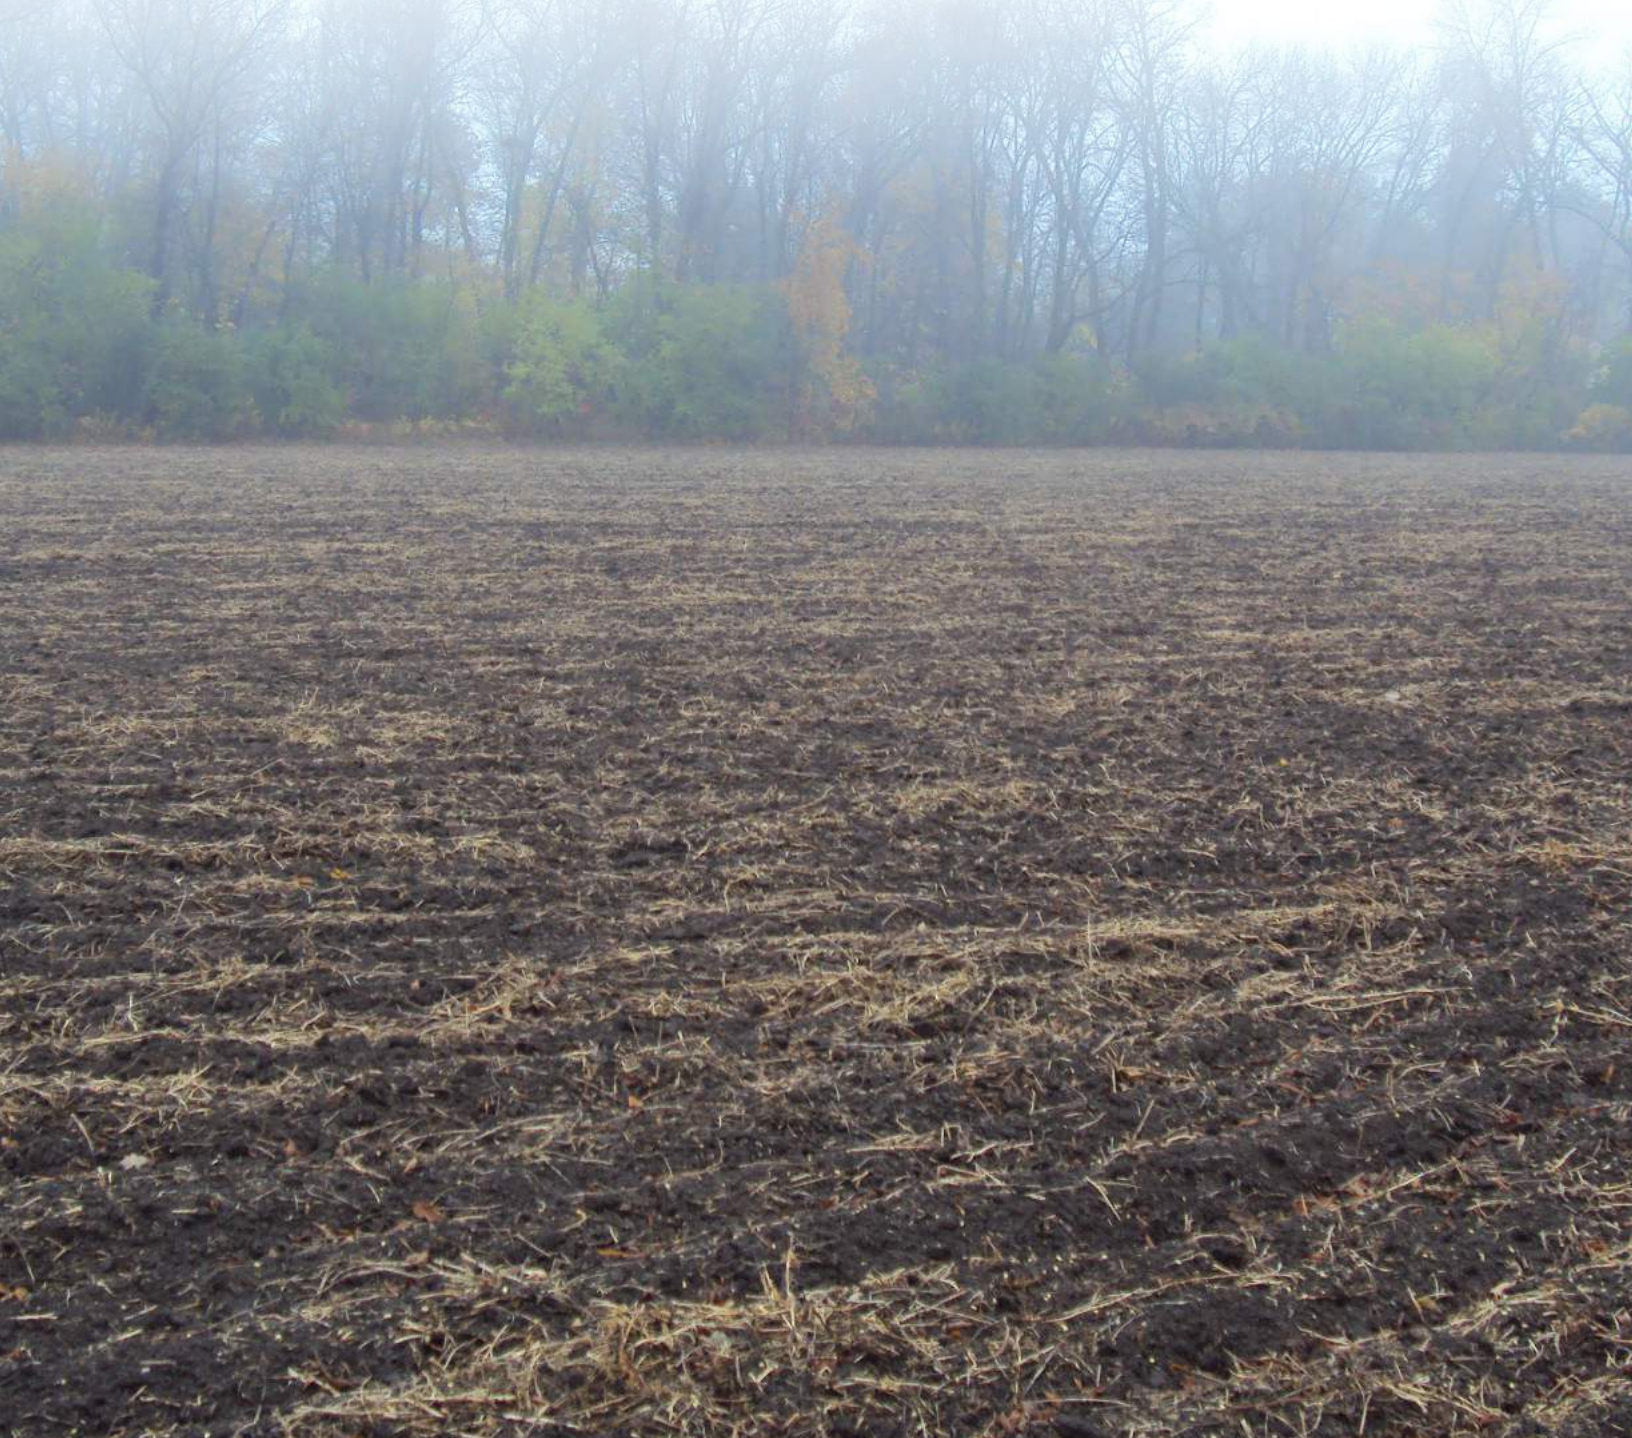
Potential wetland restoration Site #21 along Trib G Reach 3

20	≈ 16.5	Potentially Feasible	Located on private agricultural land along Tributary G and east of Middle Road
21	≈ 15	Potentially Feasible	Located on private agricultural land along Tributary G and east of Middle Road
22	≈ 46.5	Potentially Feasible	Located at headwaters of Tributary F within Cliffside Park
23	≈ 9	Limited Feasibility	Located on partially developed land owned by WE Energies
24	≈ 5	Potentially Feasible	Located on vacant private land owned by DuPont
25	≈ 5	Potentially Feasible	Located near the headwaters of Tributary A
26	≈ 5	Potentially Feasible	Located on private agricultural land along Tributary G Reach 2
